Sample Property - Anchorage, Alaska

# Home Inspection Report

Robert Landers / Home Inspections Plus

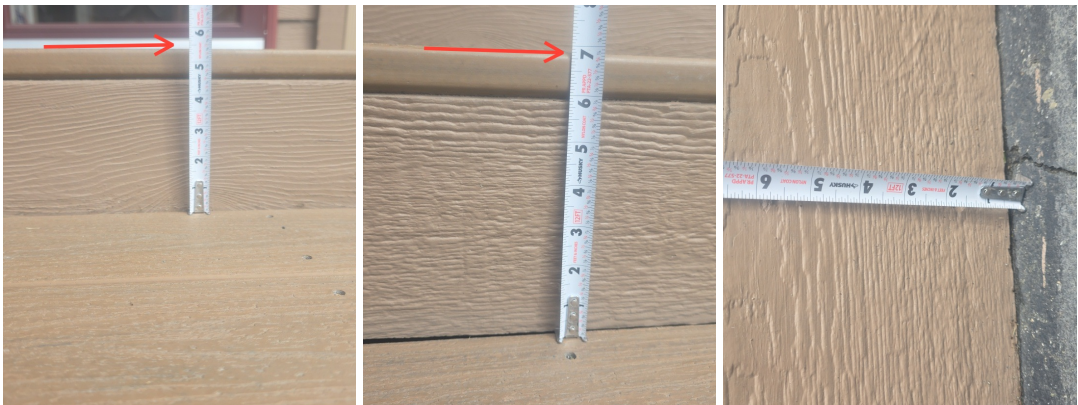
Riser Height Incorrect

Stair riser heights are inconsistent and exceed the allowable variation. Building standards generally limit riser height to 7¾ inches maximum, with no more than 3/8 inch variation between the tallest and shortest risers within a flight of stairs. Uneven risers create a tripping hazard. Recommend correction by a qualified contractor to improve safety.

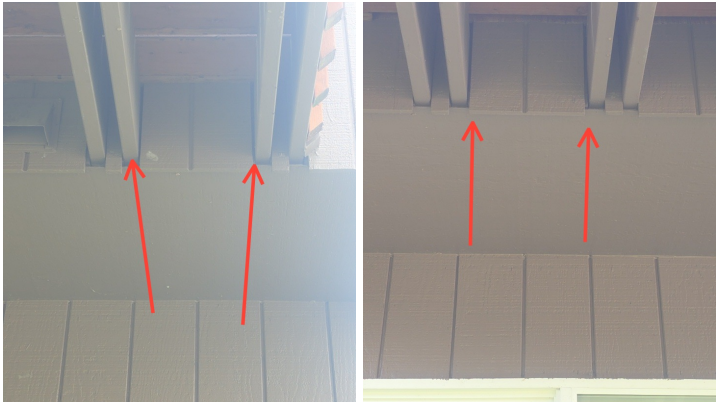
Visible gaps were noted where deck joists penetrate the exterior wall cladding. These openings may allow moisture intrusion into the wall assembly if not properly flashed and sealed. Recommend evaluation and sealing/flushing of these penetrations as needed by a qualified contractor to help prevent water intrusion.

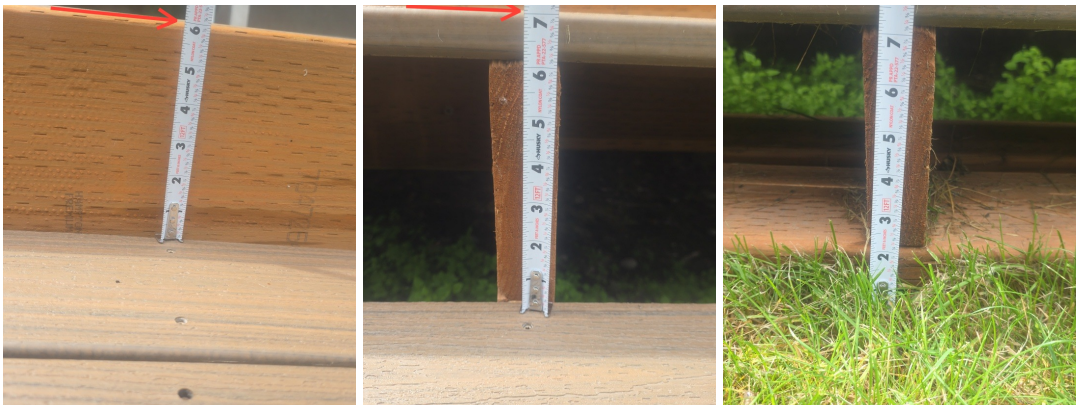
Riser Height Incorrect

Stair riser height was excessive and/or inconsistent at rear deck. Stair risers should not exceed 7 3/4 inches in height, and the greatest riser height should not exceed the smallest by more than 3/8 inch within the flight of stairs. Uneven or excessive riser heights can create a trip and fall hazard. Recommend correction by a qualified contractor.

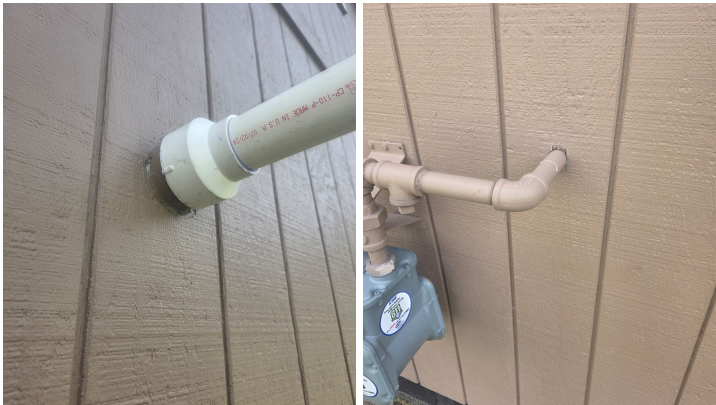
Unsealed Openings

There are a couple of pipes that are unsealed where it enters the home. Have a qualified professional seal pipes to prevent moisture intrusion.

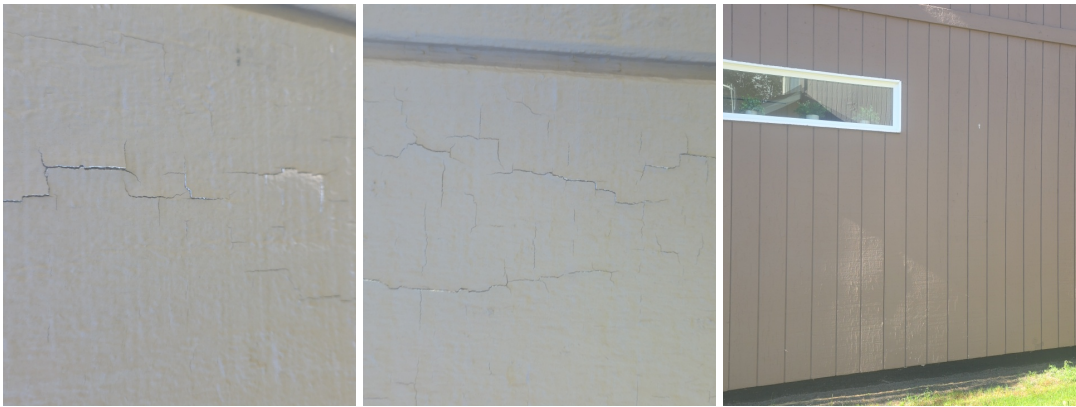
Paint Worn/ Cracking

The paint is worn/ cracking in numerous areas which could allow moisture intrusion and deterioration. Have qualified professional repaint walls as needed for wood protection/ moisture intrusion prevention.

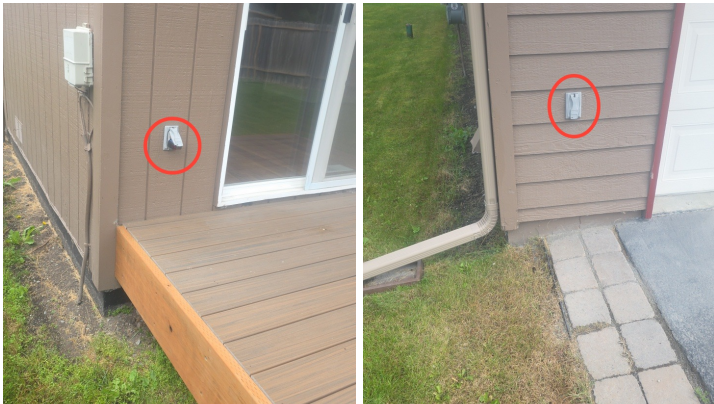
In-use Cover Missing

Current Codes require exterior receptacles to have in-use covers. Have qualified professional install in-use cover for all exterior receptacles.

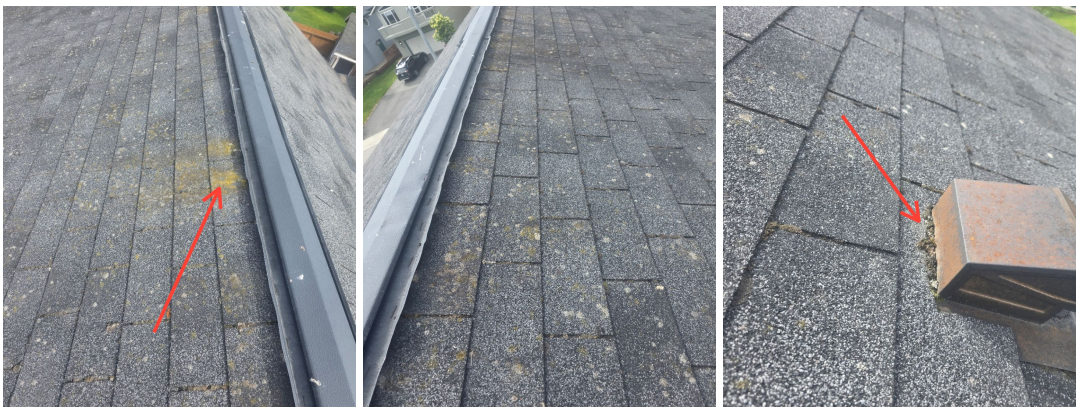
Biological Growth Present On Roof

Biological growth (moss and/or lichen) was observed on portions of the roof covering. Over time, biological growth can retain moisture, accelerate deterioration of asphalt shingles, and reduce the roof's expected service life. The roof should be cleaned using methods approved for asphalt shingles (avoid pressure washing), and monitored for further deterioration. Repair or replacement of damaged shingles should be performed as needed by a qualified roofing contractor.

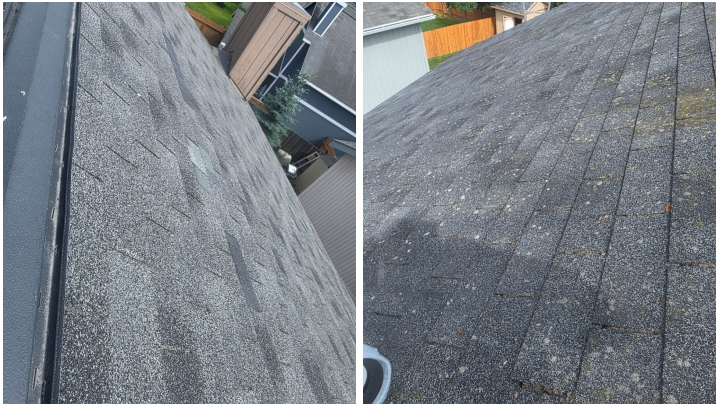
Roofing At/ Near End Of Life

The roofing appears to be at or near the end of its estimated life expectancy as it appears to be the original roof. Have qualified roofing professional replace roofing to prevent leaks/ moisture intrusion.

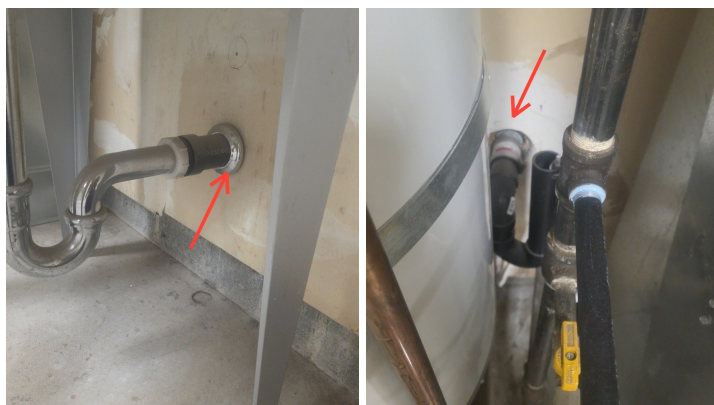
### Missing Firestop At ABS Pipe Penetration

A combustible ABS pipe penetrates the garage-to-house separation wall without an approved firestop assembly. Proper firestopping is required to help maintain the fire-resistance rating of the garage separation and slow the spread of fire and smoke. Recommend installation of a code-compliant firestop system (typically an intumescent firestop collar or other approved assembly) by a qualified contractor.

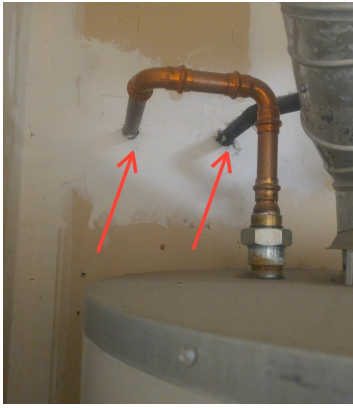
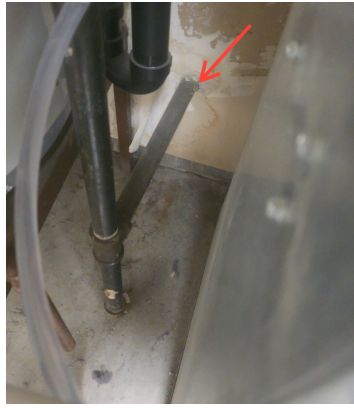
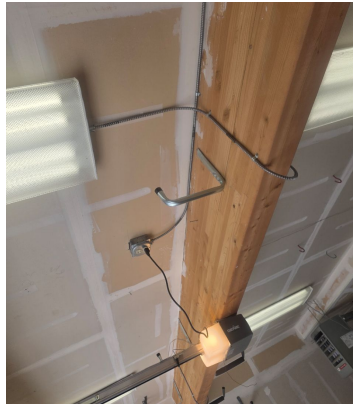
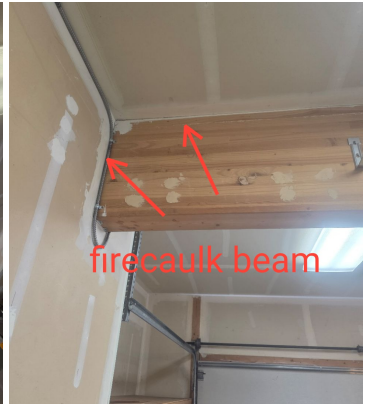
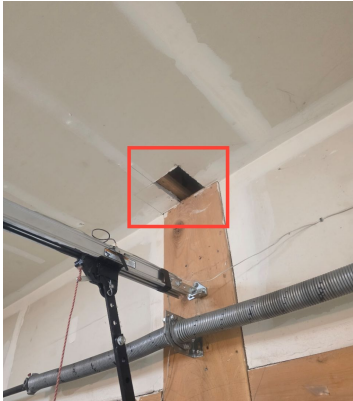
### Unsealed Firewall Penetrations

Unsealed penetrations were observed in the garage firewall/fire separation assembly. Open penetrations can compromise the effectiveness of the fire barrier. Recommend sealing openings as needed to improve fire separation integrity.

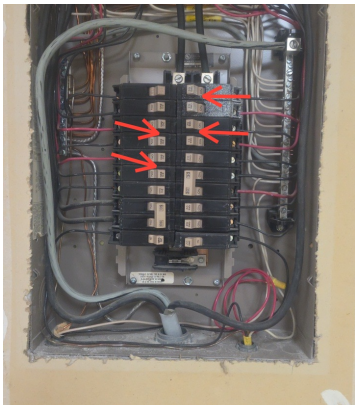
Shared Neutral Circuits

Shared Neutral Circuits were noted in the panel. Shared neutral circuits can create a shock hazard if the associated breakers are not properly tied together, as one circuit may remain energized while work is being performed on the other. Have qualified professional install approved handle ties or replace with proper 2 pole breaker as needed.

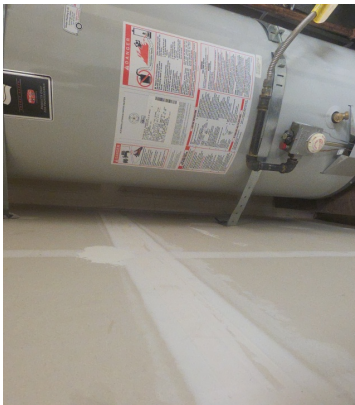
Seismic Blocking Missing

Required seismic blocking was not installed above the water heater. In seismic areas, upper blocking helps limit movement of the water heater during an earthquake and reduces the risk of damage to the water heater and connected plumbing. Recommend installation of approved seismic blocking by a qualified contractor.

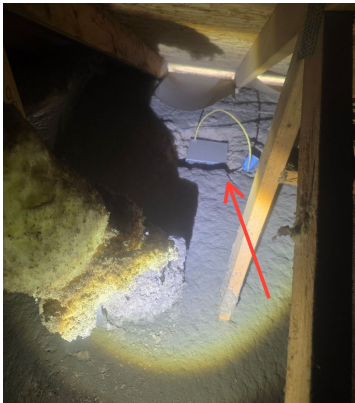
Insulation Missing Over Exhaust Fan

Insulation was missing over the bathroom exhaust fan housing in the attic. This can increase heat loss, reduce energy efficiency, and may contribute to condensation around the fan assembly during cold weather. Recommend installing insulation over and around the fan housing as appropriate, while maintaining required clearances if the fan is not insulation-contact (IC) rated. Installation should follow the manufacturer's instructions.

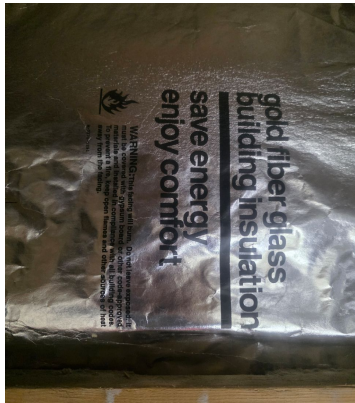
Exposed Insulation Facing

Faced fiberglass insulation with exposed kraft paper backing was observed. The insulation facing is labeled as not intended to be left exposed, as the paper facing is combustible. Exposed faced insulation may present a potential fire hazard in accessible areas. Recommend covering exposed insulation with an approved thermal barrier or further evaluation/correction by a qualified contractor.

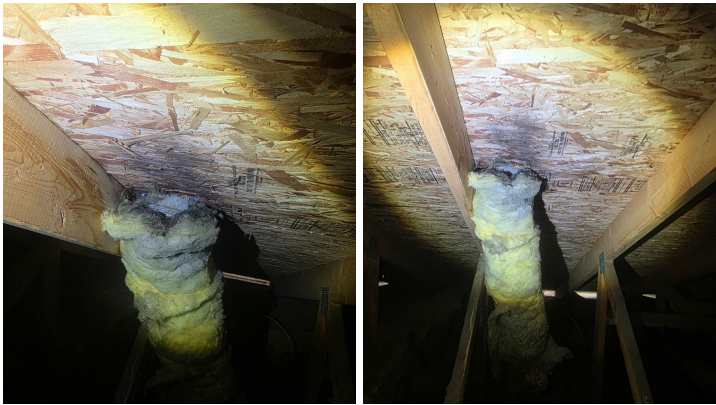
There are a ducts in the attic that dont appear to be properly sealed to the roof cap surface resulting in warm air leaking into attic and microbial growth. Have qualified professional seal ducting as needed and clean and seal microbial growth.

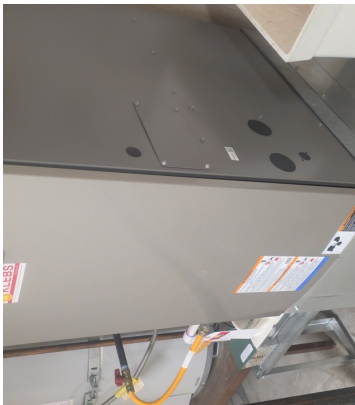
Recent Service Tag Missing

There was no service tag indicating its been maintained or serviced recently. Recommend having a qualified plumbing contractor service and inspect the unit and perform any repairs needed.

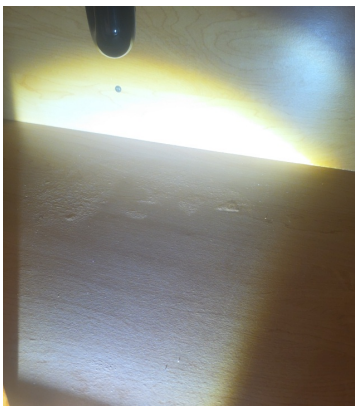
Signs Of Previous Leak Noted

Evidence of previous water intrusion was observed within the cabinet. The source of the leak was not active at the time of inspection; however, damage to cabinet materials was noted. Recommend repairing or replacing damaged materials as needed and monitoring for signs of continued leakage.

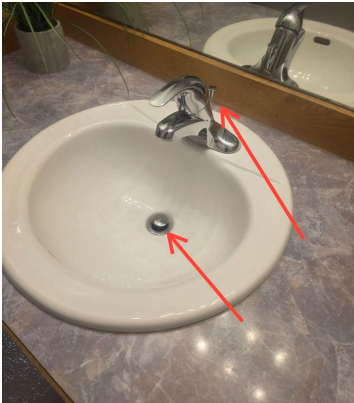
Stopper Inoperative

The stopped at the sink is Inoperative. Have qualified professional repair as needed to restore proper operation.

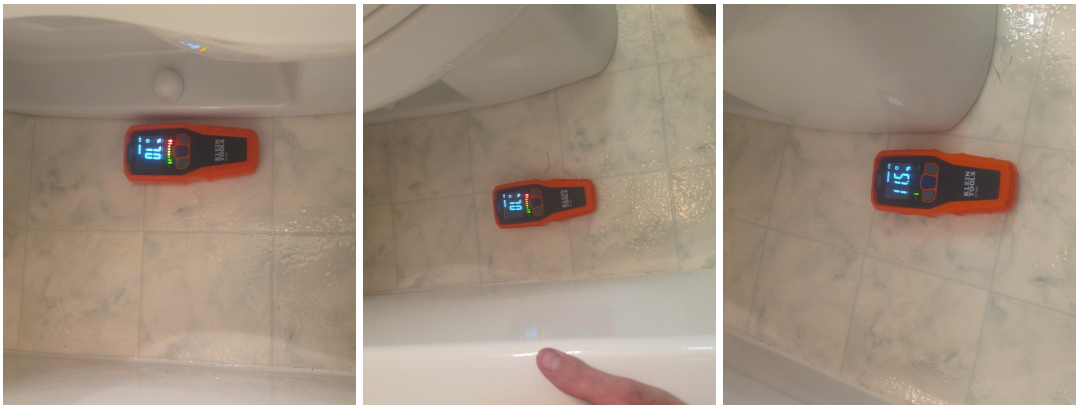
Elevated Moisture Levels At Toilet Base

Elevated moisture levels were detected in the flooring adjacent to the toilet during the inspection. The source of the moisture could not be conclusively determined at the time of inspection; however, readings may indicate leakage at the toilet wax ring, supply connection, condensation, or prior water intrusion. Recommend further evaluation and repairs as needed by a qualified plumbing contractor. Damaged materials should be replaced after the moisture source has been corrected.

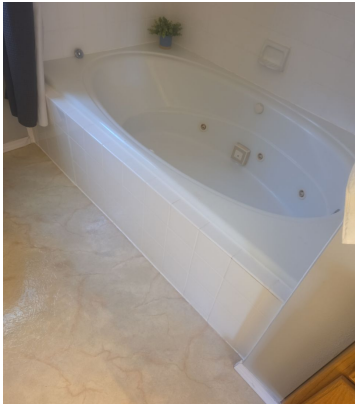
No service access panel was identified for the jetted bathtub. The pump and associated components should be readily accessible for maintenance and repair. Recommend installation of a service access panel by a qualified contractor to provide proper access to the equipment.

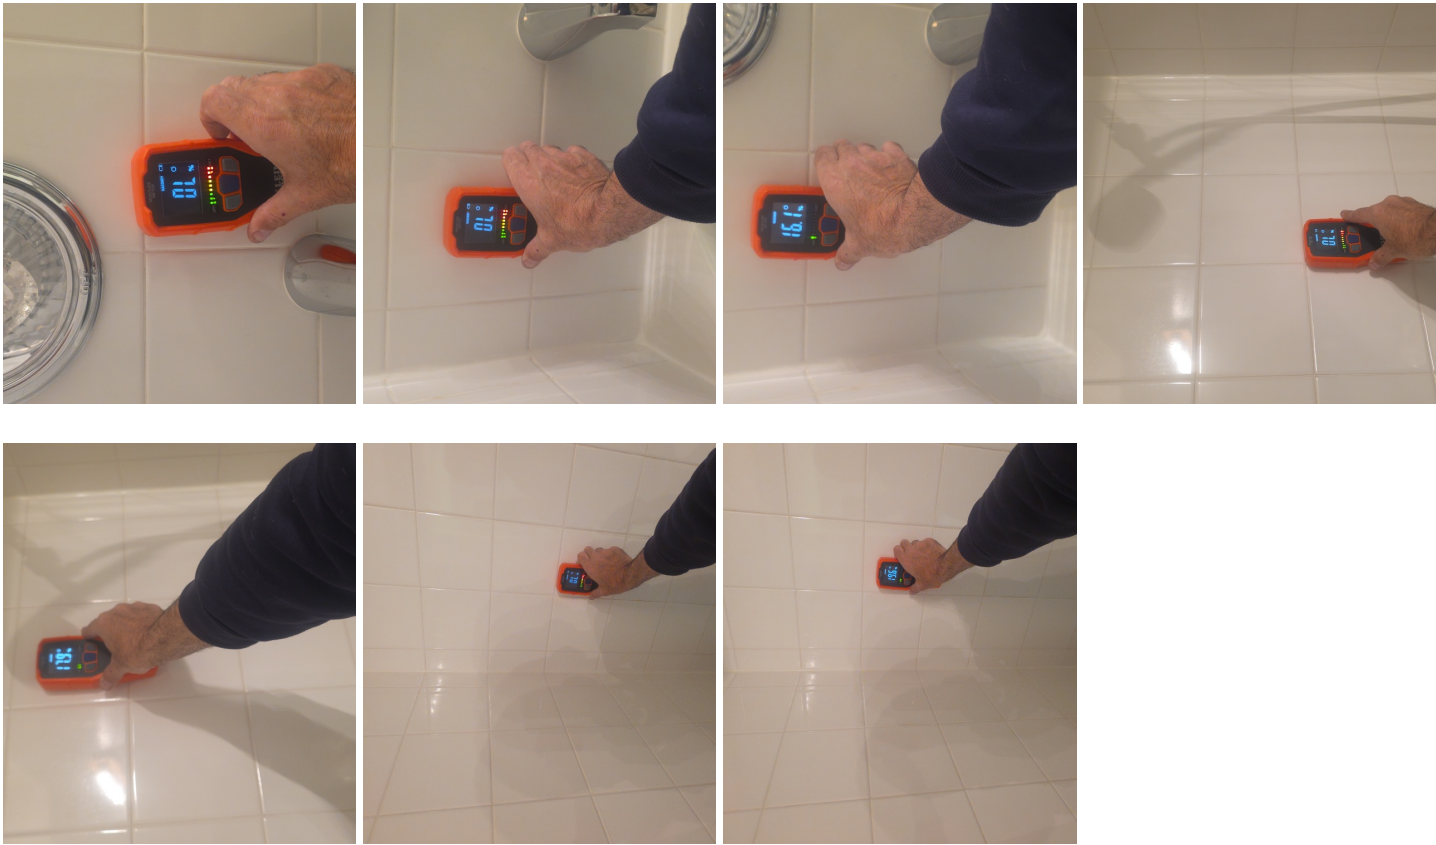
Moisture Detected Behind Shower Walls

Moisture was detected behind the shower tile using a moisture meter, indicating moisture intrusion behind the finished surface. The extent of concealed damage could not be determined during this visual inspection. Recommend evaluation by a qualified contractor and repair as needed, which may include removal of tile and replacement of any damaged materials.

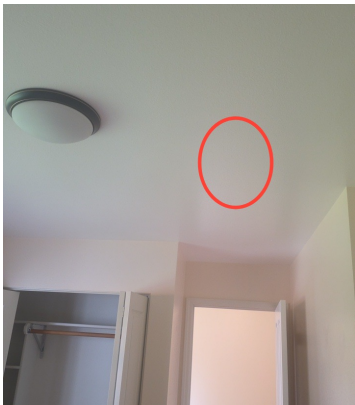
Smoke Detectors Missing

At least one smoke detector is missing. Have qualified contractor install smoke alarms to meet current requirements.

Note: MOA Policy R.18 requires interconnection of battery operated types.

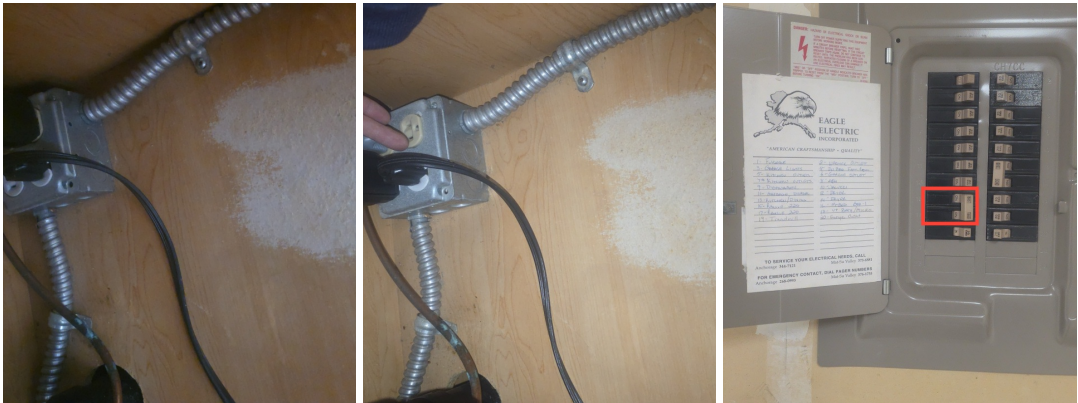
Gfci Protection Missing

Current codes require gfci protection for all 120 and 240v receptacles in a kitchen including the range receptacle. Have qualified professional ensure all 120v and 240v receptacles in the kitchen are gfci protected.  
Note 3-wire 240v cords and receptacles need to be replaced with 4-wire for proper seperation of ground and neutral conductors.

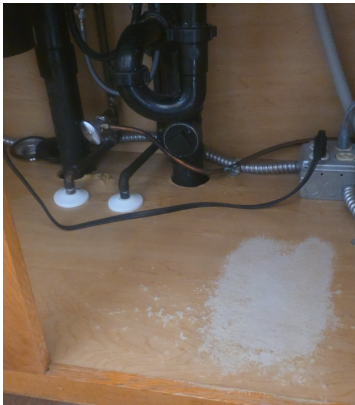
Signs Of Previous Leaks

There are signs of previous leaks in the cabinet below the sink. Have qualified professional ensure leak free operation and repair under sink area as needed.

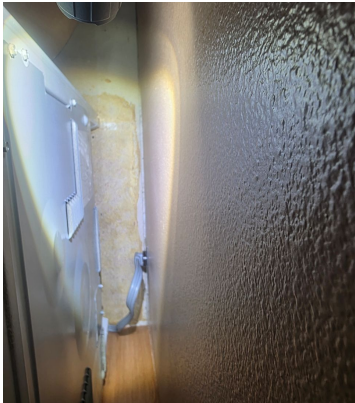
Anti-tip Missing

The anti-tip bracket is missing. Have qualified professional install anti-tip bracket for child safety.

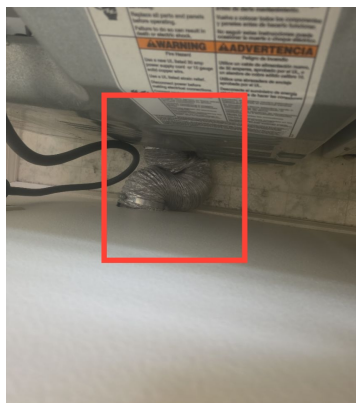
Dryer Vent Duct Restricted

The flexible dryer exhaust duct was excessively kinked/compressed behind the dryer, restricting airflow. Restricted dryer exhaust can reduce dryer performance, increase lint accumulation, and create a potential fire hazard. Recommend replacing the flexible duct with a properly installed rigid or semi-rigid metal transition duct and ensuring the exhaust path is free of excessive bends or kinks.

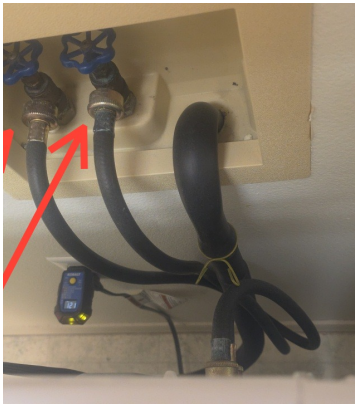
Rubber washing machine supply hoses were installed. Rubber hoses are more prone to deterioration and failure over time than steel braided hoses, which can result in signifi-

cant water damage if a hose ruptures. Recommend replacing the existing rubber hoses with quality steel braided supply hoses as a preventative maintenance upgrade.

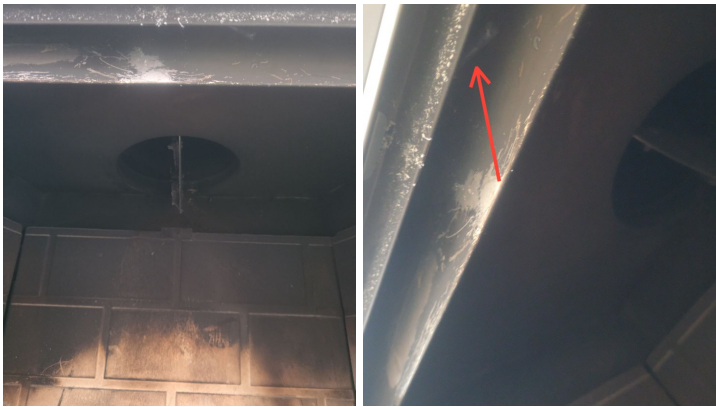
The fireplace damper was missing its operating handle and did not remain in the closed position during inspection. A properly functioning damper is necessary to control air-flow, improve energy efficiency, and help ensure safe fireplace operation. Recommend a Level 2 chimney inspection and repair or replacement of the damper assembly by a qualified chimney professional prior to using the fireplace.

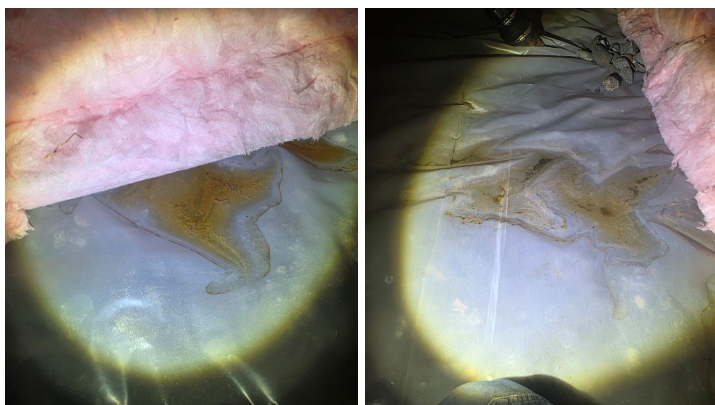
#### Moisture Present At Crawlspace Vapor Barrier

Standing water and staining were observed on top of the crawlspace vapor barrier. The source of the moisture could not be determined during the inspection. A qualified contractor should further evaluate the crawlspace to identify and correct the source of the moisture. After repairs are completed, any standing water should be removed, and the crawlspace should be monitored to verify the issue has been resolved. Continued moisture intrusion can contribute to wood decay, mold growth, and other moisture-related damage.
