Sample Property - Anchorage, Alaska

# Home Inspection Report

Robert Landers / Home Inspections Plus

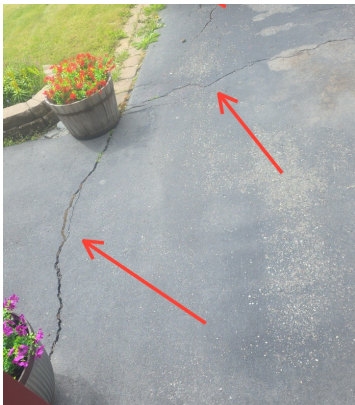
Asphalt Driveway Cracking

The asphalt driveway exhibits multiple cracks and signs of deterioration. If left unsealed, moisture can enter the cracks, leading to additional damage from freeze-thaw cycles and normal wear. Recommend cleaning and sealing the cracks as needed and monitoring the driveway for continued deterioration. More extensive repairs or resurfacing may be needed as the driveway continues to age.

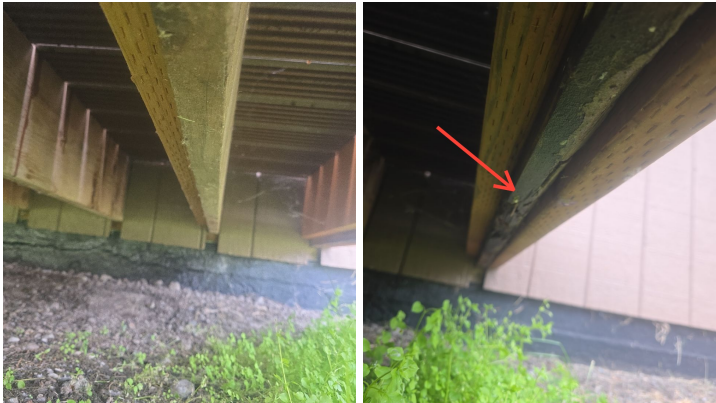
Deteriorated Wood At Deck Framing

Wood deterioration/rot was noted along the lower edge of existing deck framing. Newer framing appears to have been installed alongside portions of the older framing, with deteriorated material remaining within the deck structure. The full extent of deterioration and condition of concealed surfaces could not be determined during the visual inspection. Recommend further evaluation and repair/replacement of deteriorated framing by a qualified contractor.

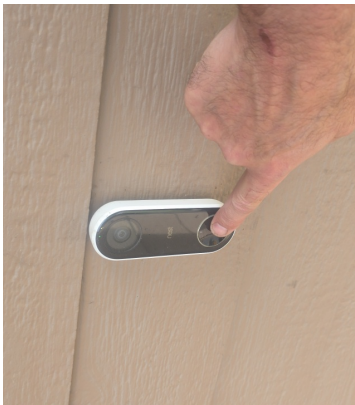
The doorbell did not function. Have qualified professional repair as needed to restore doorbell to operational.

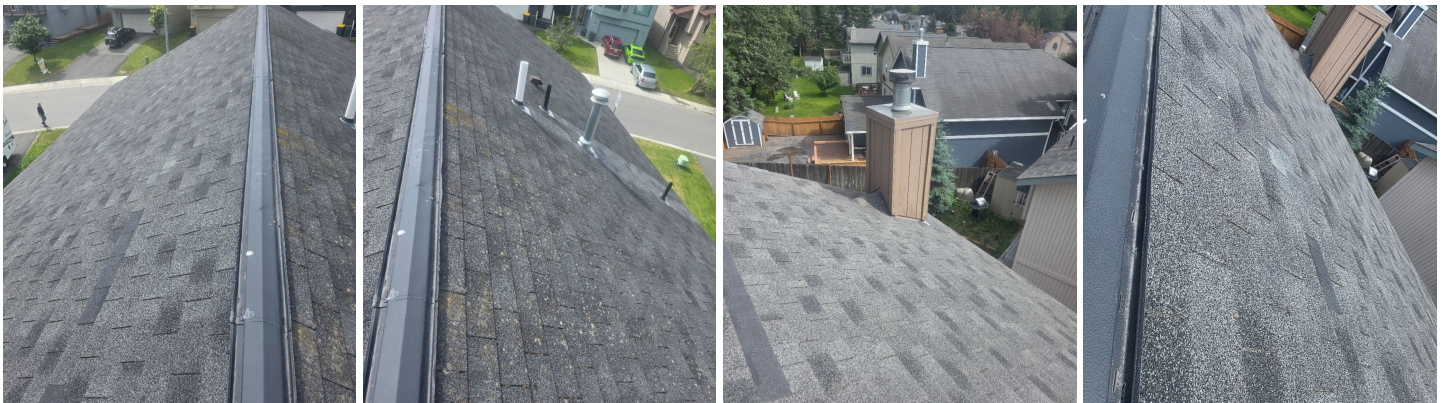
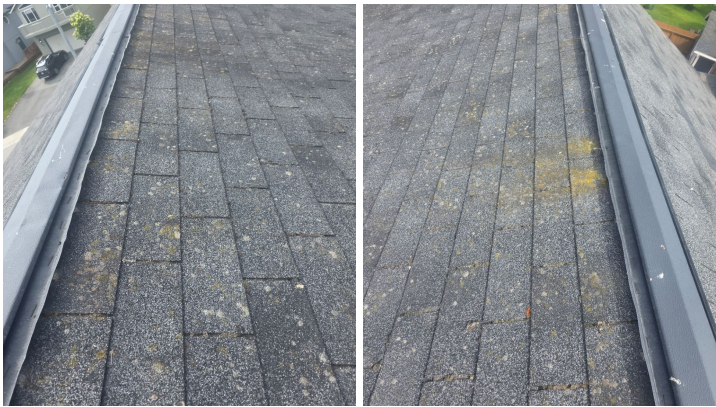
Biological Growth Present On Roof

Biological growth (moss and/or lichen) was observed on portions of the roof covering. Over time, biological growth can retain moisture, accelerate deterioration of asphalt shingles, and reduce the roof's expected service life. The roof should be cleaned using methods approved for asphalt shingles (avoid pressure washing), and monitored for further deterioration. Repair or replacement of damaged shingles should be performed as needed by a qualified roofing contractor.

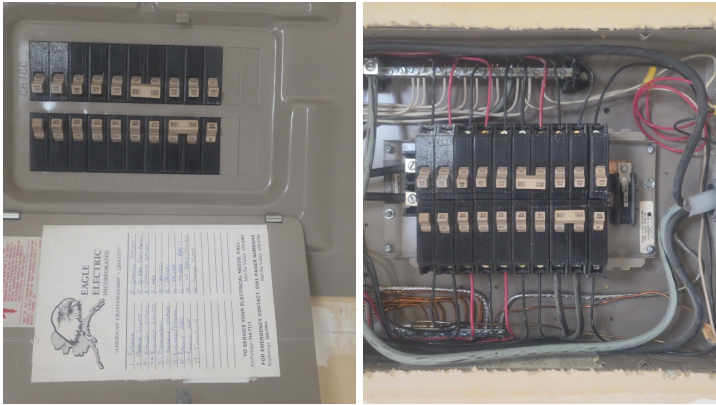
Shared Neutral Circuits

Shared Neutral Circuits were noted in the panel. Shared neutral circuits can create a shock hazard if the associated breakers are not properly tied together, as one circuit may remain energized while work is being performed on the other. Have qualified professional install approved handle ties or replace with proper 2 pole breaker as needed.

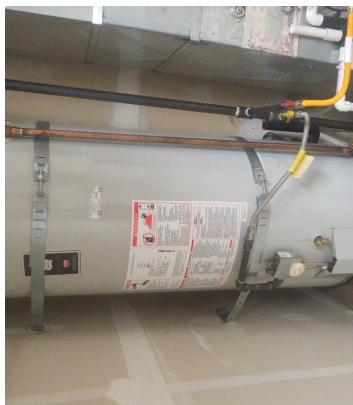
Seismic Blocking Missing

Required seismic blocking was not installed above the water heater. In seismic areas, upper blocking helps limit movement of the water heater during an earthquake and reduces the risk of damage to the water heater and connected plumbing. Recommend installation of approved seismic blocking by a qualified contractor.

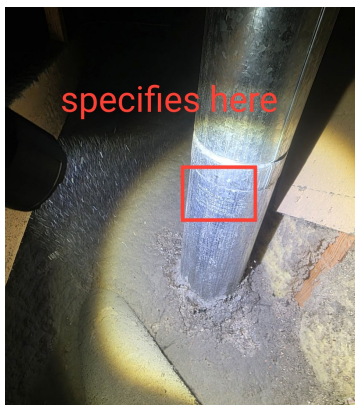
A minimum of 1 inch of clearance is required between metal flue pipes and combustible materials like wood, insulation, and drywall.

Have a qualified contractor install a heat shield to space the insulation back from the flue pipe at least 1". Unless its determined to be the abandoned flue for the crawlspace units no longer in use.

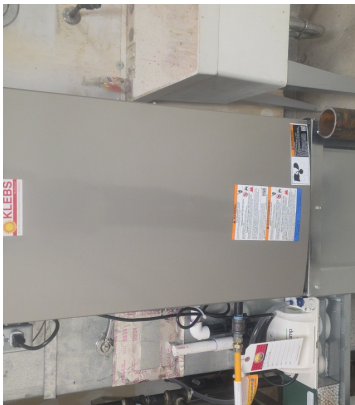
Recent Service Tag Missing

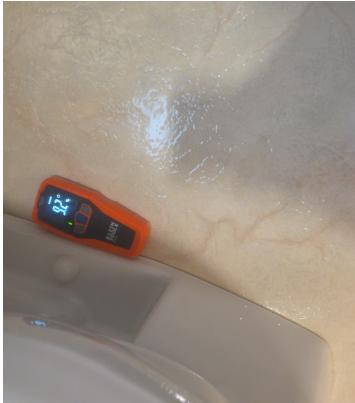
Elevated Moisture Levels At Toilet Base

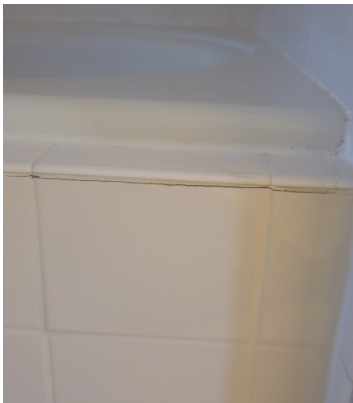
**Cracked/ Loose Tile Grout At Tub Surround**

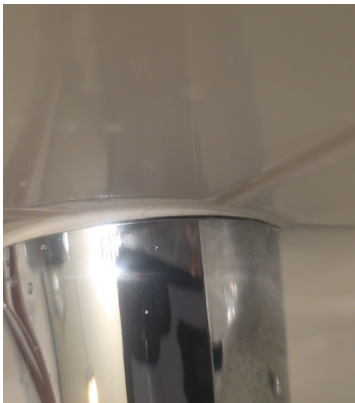
**Jetted Tub Lacks Service Panel**

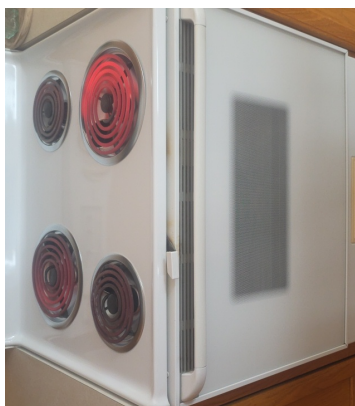
Anti-tip Missing

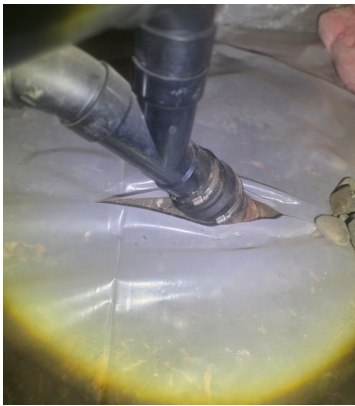
Not Sealed

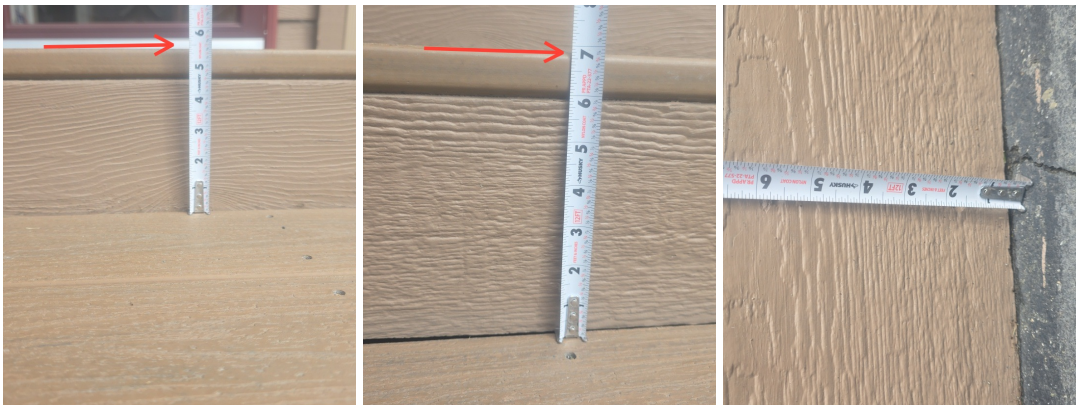
Riser Height Incorrect

Stair riser heights are inconsistent and exceed the allowable variation. Building standards generally limit riser height to 7¾ inches maximum, with no more than 3/8 inch variation between the tallest and shortest risers within a flight of stairs. Uneven risers create a tripping hazard. Recommend correction by a qualified contractor to improve safety.

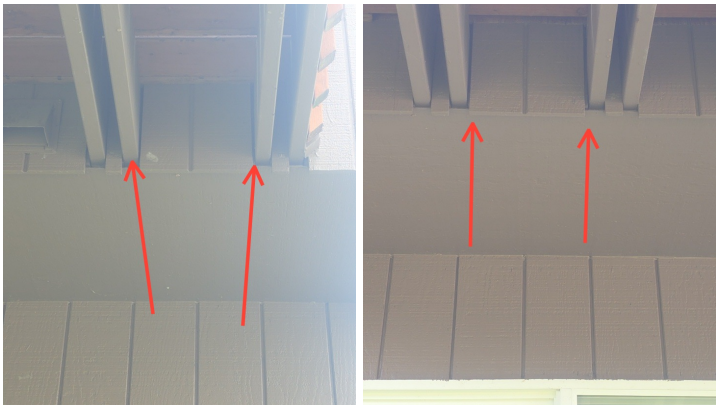
Gaps At Deck Joist Penetrations

Visible gaps were noted where deck joists penetrate the exterior wall cladding. These openings may allow moisture intrusion into the wall assembly if not properly flashed and sealed. Recommend evaluation and sealing/flushing of these penetrations as needed by a qualified contractor to help prevent water intrusion.

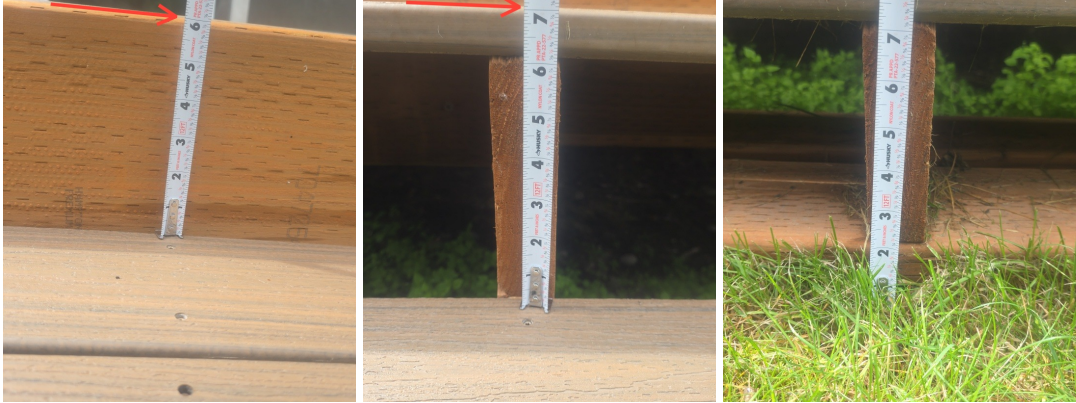
Riser Height Incorrect

Stair riser height was excessive and/or inconsistent at rear deck. Stair risers should not exceed 7 3/4 inches in height, and the greatest riser height should not exceed the smallest by more than 3/8 inch within the flight of stairs. Uneven or excessive riser heights can create a trip and fall hazard. Recommend correction by a qualified contractor.

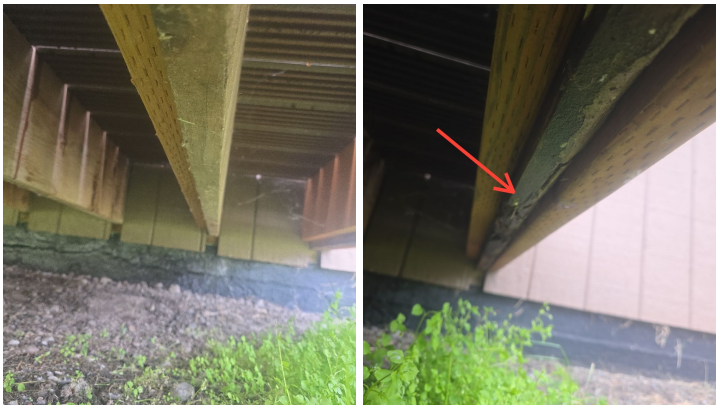
### Deteriorated Wood At Deck Framing

Wood deterioration/rot was noted along the lower edge of existing deck framing. Newer framing appears to have been installed alongside portions of the older framing, with deteriorated material remaining within the deck structure. The full extent of deterioration and condition of concealed surfaces could not be determined during the visual inspection. Recommend further evaluation and repair/replacement of deteriorated framing by a qualified contractor.

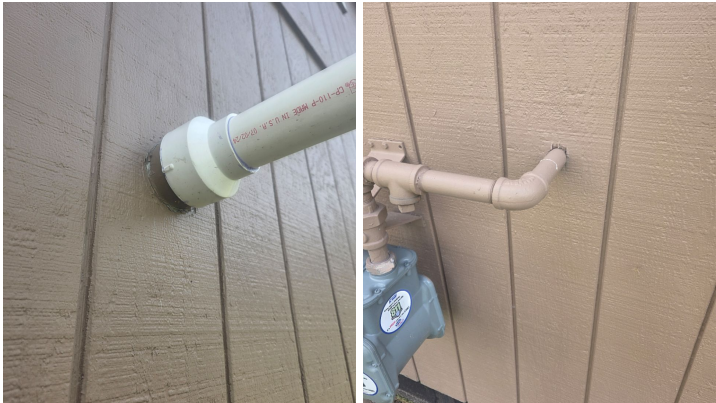
There are a couple of pipes that are unsealed where it enters the home. Have a qualified professional seal pipes to prevent moisture intrusion.

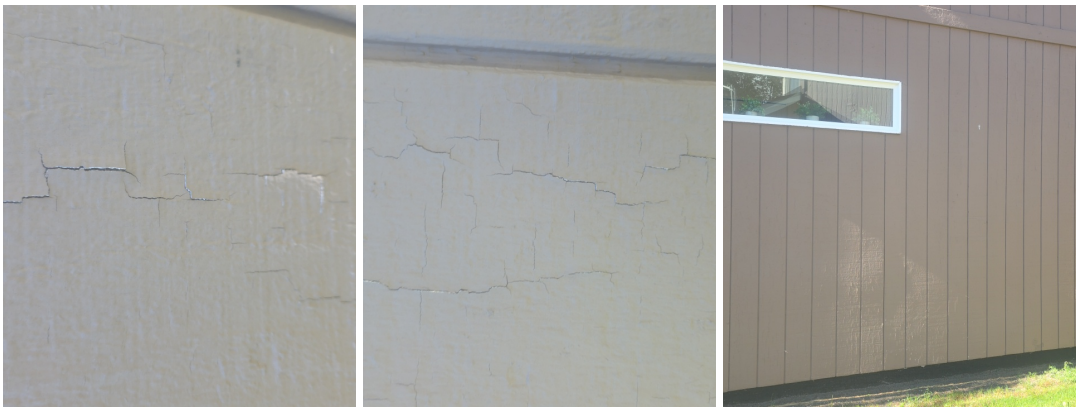
Paint Worn/ Cracking

The paint is worn/ cracking in numerous areas which could allow moisture intrusion and deterioration. Have qualified professional repaint walls as needed for wood protection/ moisture intrusion prevention.

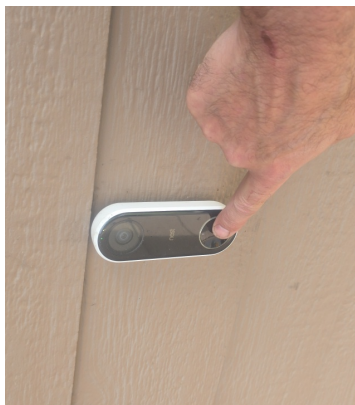
The doorbell did not function. Have qualified professional repair as needed to restore doorbell to operational.

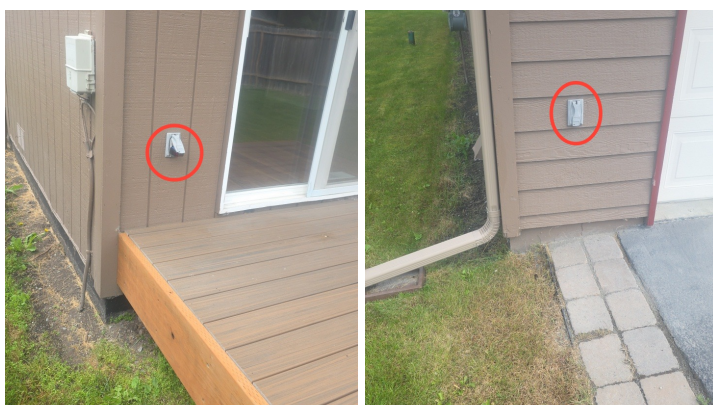
#### In-use Cover Missing

Current Codes require exterior receptacles to have in-use covers. Have qualified professional install in-use cover for all exterior receptacles.

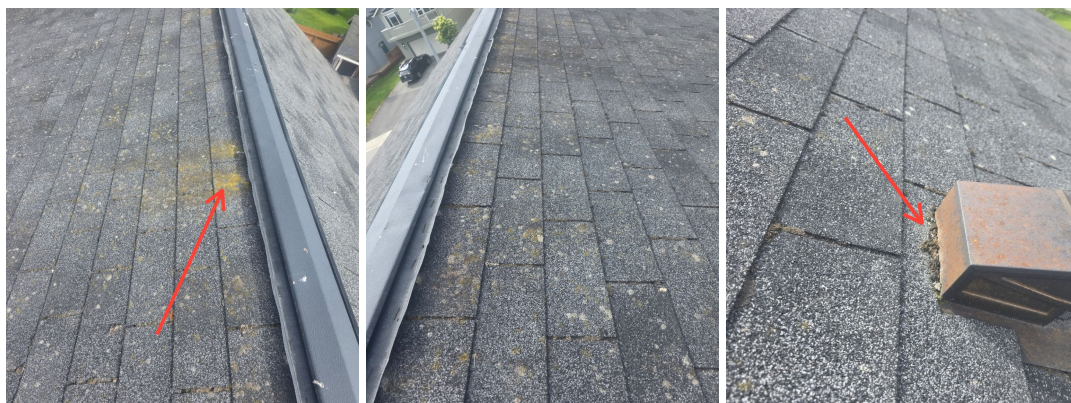
Biological growth (moss and/or lichen) was observed on portions of the roof covering. Over time, biological growth can retain moisture, accelerate deterioration of asphalt shingles, and reduce the roof's expected service life. The roof should be cleaned using methods approved for asphalt shingles (avoid pressure washing), and monitored for

further deterioration. Repair or replacement of damaged shingles should be performed as needed by a qualified roofing contractor.

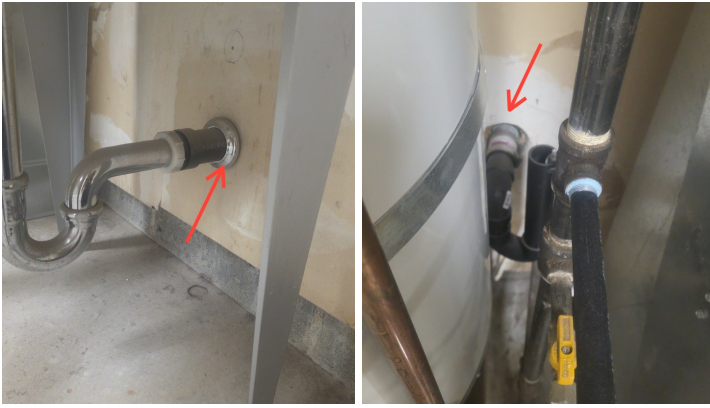
##### Missing Firestop At ABS Pipe Penetration

A combustible ABS pipe penetrates the garage-to-house separation wall without an approved firestop assembly. Proper firestopping is required to help maintain the fire-resistance rating of the garage separation and slow the spread of fire and smoke. Recommend installation of a code-compliant firestop system (typically an intumescent firestop collar or other approved assembly) by a qualified contractor.

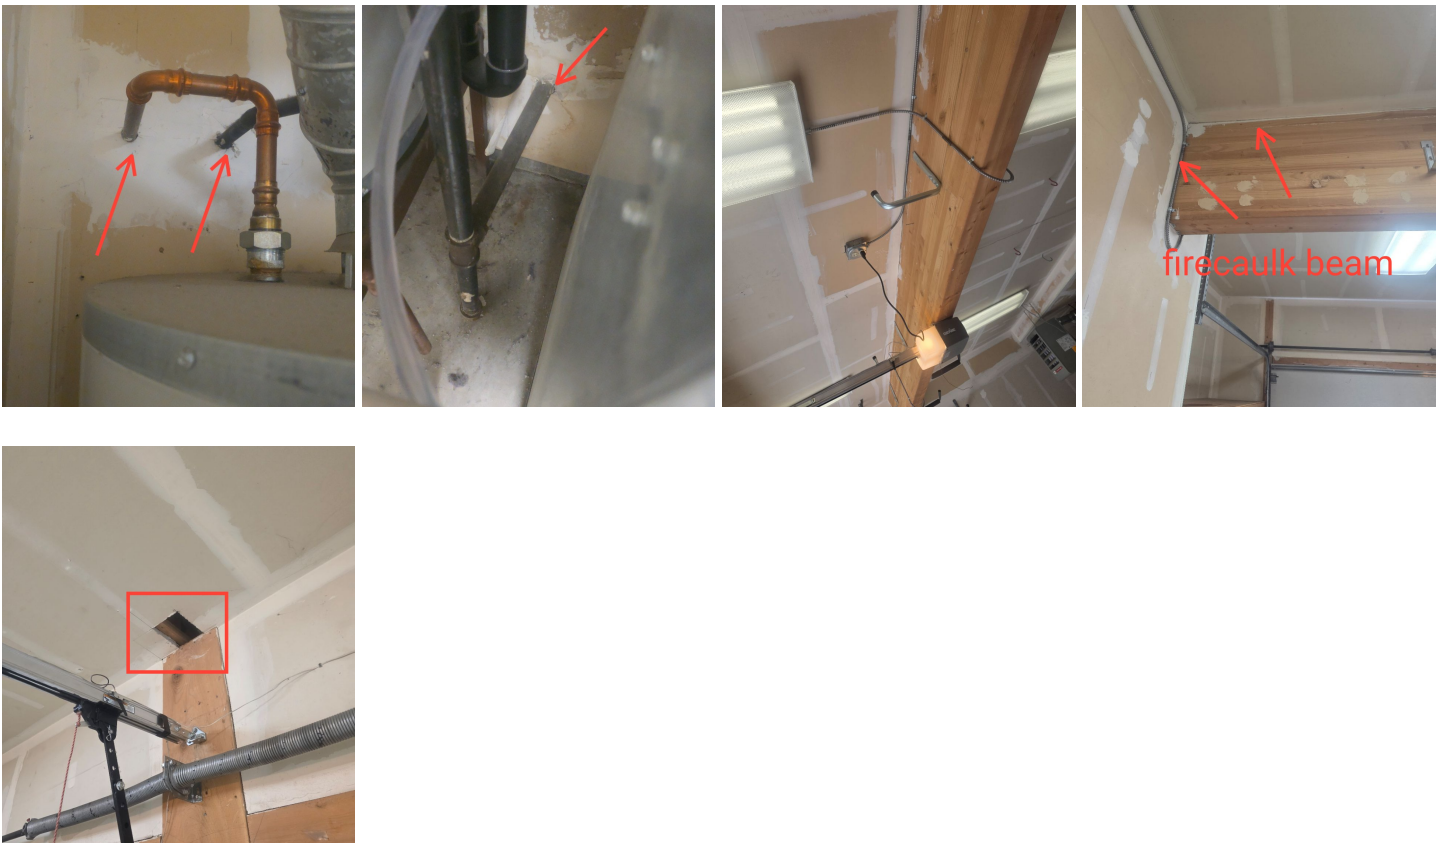
### Unsealed Firewall Penetrations

Unsealed penetrations were observed in the garage firewall/fire separation assembly. Open penetrations can compromise the effectiveness of the fire barrier. Recommend sealing openings as needed to improve fire separation integrity.

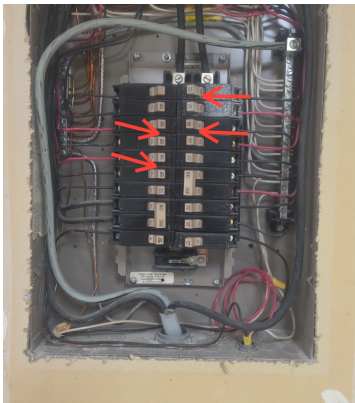
Shared Neutral Circuits

Shared Neutral Circuits were noted in the panel. Shared neutral circuits can create a shock hazard if the associated breakers are not properly tied together, as one circuit may remain energized while work is being performed on the other. Have qualified professional install approved handle ties or replace with proper 2 pole breaker as needed.

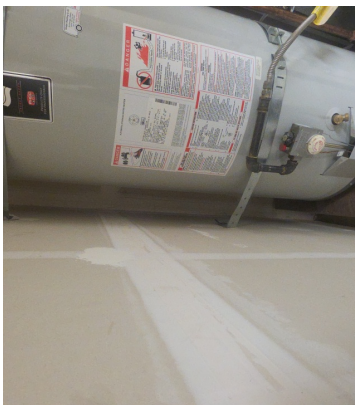
Seismic Blocking Missing

Required seismic blocking was not installed above the water heater. In seismic areas, upper blocking helps limit movement of the water heater during an earthquake and reduces the risk of damage to the water heater and connected plumbing. Recommend installation of approved seismic blocking by a qualified contractor.

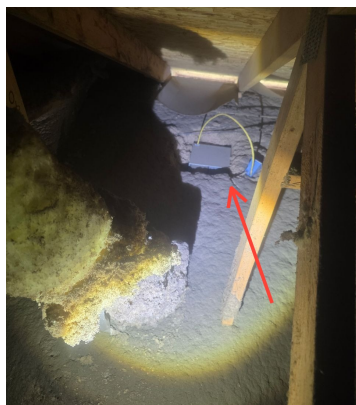
##### Insulation Missing Over Exhaust Fan

Insulation was missing over the bathroom exhaust fan housing in the attic. This can increase heat loss, reduce energy efficiency, and may contribute to condensation around the fan assembly during cold weather. Recommend installing insulation over and around the fan housing as appropriate, while maintaining required clearances if the fan is not insulation-contact (IC) rated. Installation should follow the manufacturer's instructions.

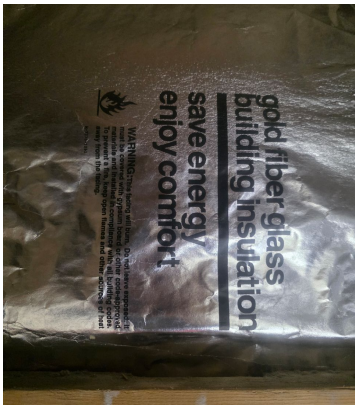
At hatch

##### Exposed Insulation Facing

Faced fiberglass insulation with exposed kraft paper backing was observed. The insulation facing is labeled as not intended to be left exposed, as the paper facing is combustible. Exposed faced insulation may present a potential fire hazard in accessible areas. Recommend covering exposed insulation with an approved thermal barrier or further evaluation/correction by a qualified contractor.

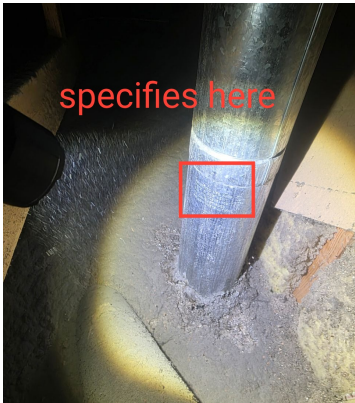
Insulation Touching Flue Pipe

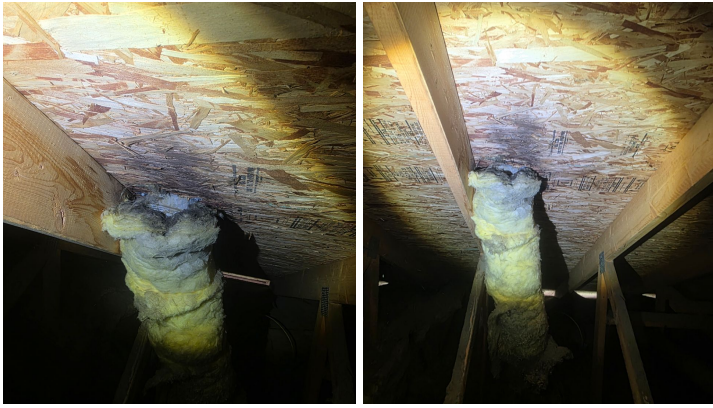
There are a ducts in the attic that dont appear to be properly sealed to the roof cap surface resulting in warm air leaking into attic and microbial growth. Have qualified professional seal ducting as needed and clean and seal microbial growth.

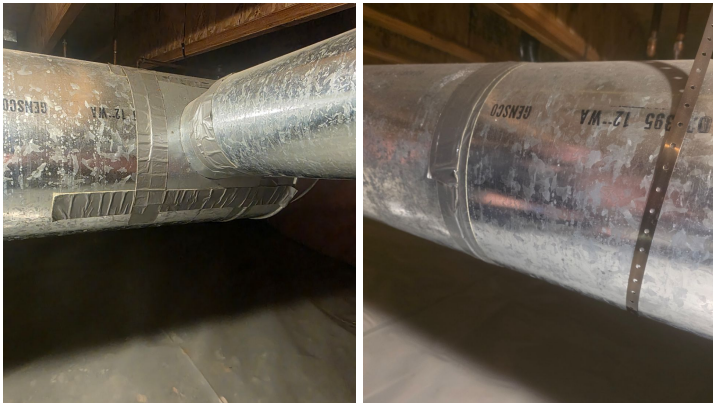
Duct tape was observed at heating duct connections. Conventional duct tape commonly fails with age and temperature changes. Have qualified professional remove duct tape and repair/seal with appropriate UL-rated HVAC materials.

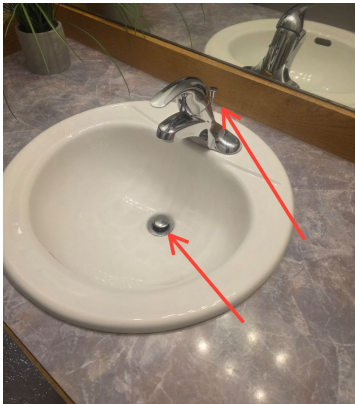
The stopped at the sink is Inoperative. Have qualified professional repair as needed to restore proper operation.

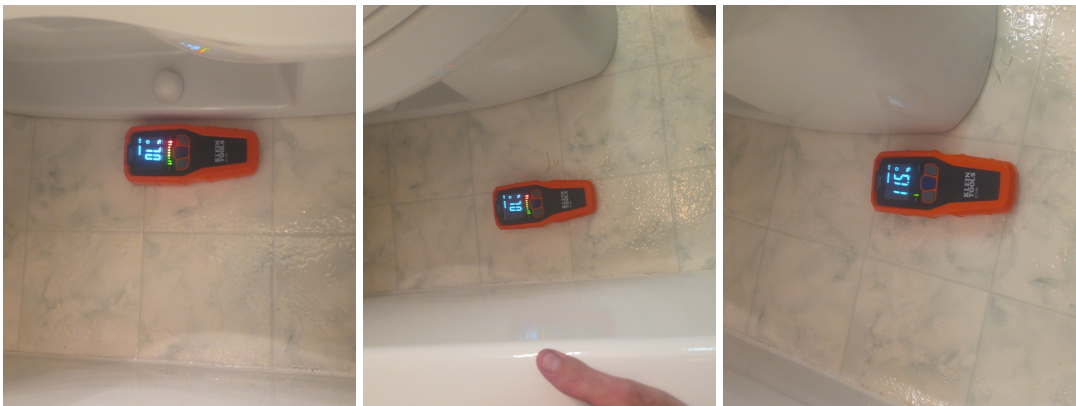
Elevated Moisture Levels At Toilet Base

Elevated moisture levels were detected in the flooring adjacent to the toilet during the inspection. The source of the moisture could not be conclusively determined at the time of inspection; however, readings may indicate leakage at the toilet wax ring, supply connection, condensation, or prior water intrusion. Recommend further evaluation and repairs as needed by a qualified plumbing contractor. Damaged materials should be replaced after the moisture source has been corrected.

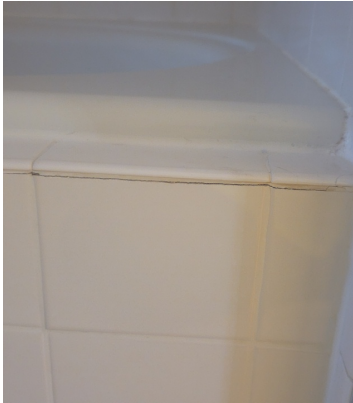
### Cracked/ Loose Tile Grout At Tub Surround

A hairline crack was observed in the tile grout at the top edge of the bathtub surround near the outside corner. Cracked or loose tile and grout can allow moisture intrusion, potentially leading to deterioration of underlying materials over time. Recommend replacing the damaged tile grout or sealing the crack as appropriate and maintaining the surrounding caulk to help prevent water intrusion.

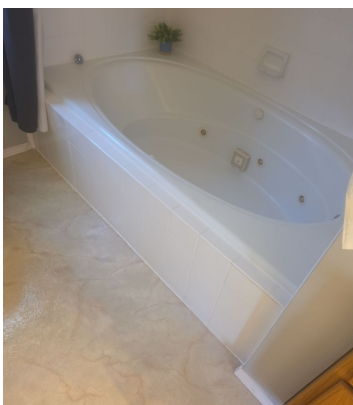
### Jetted Tub Lacks Service Panel

No service access panel was identified for the jetted bathtub. The pump and associated components should be readily accessible for maintenance and repair. Recommend installation of a service access panel by a qualified contractor to provide proper access to the equipment.

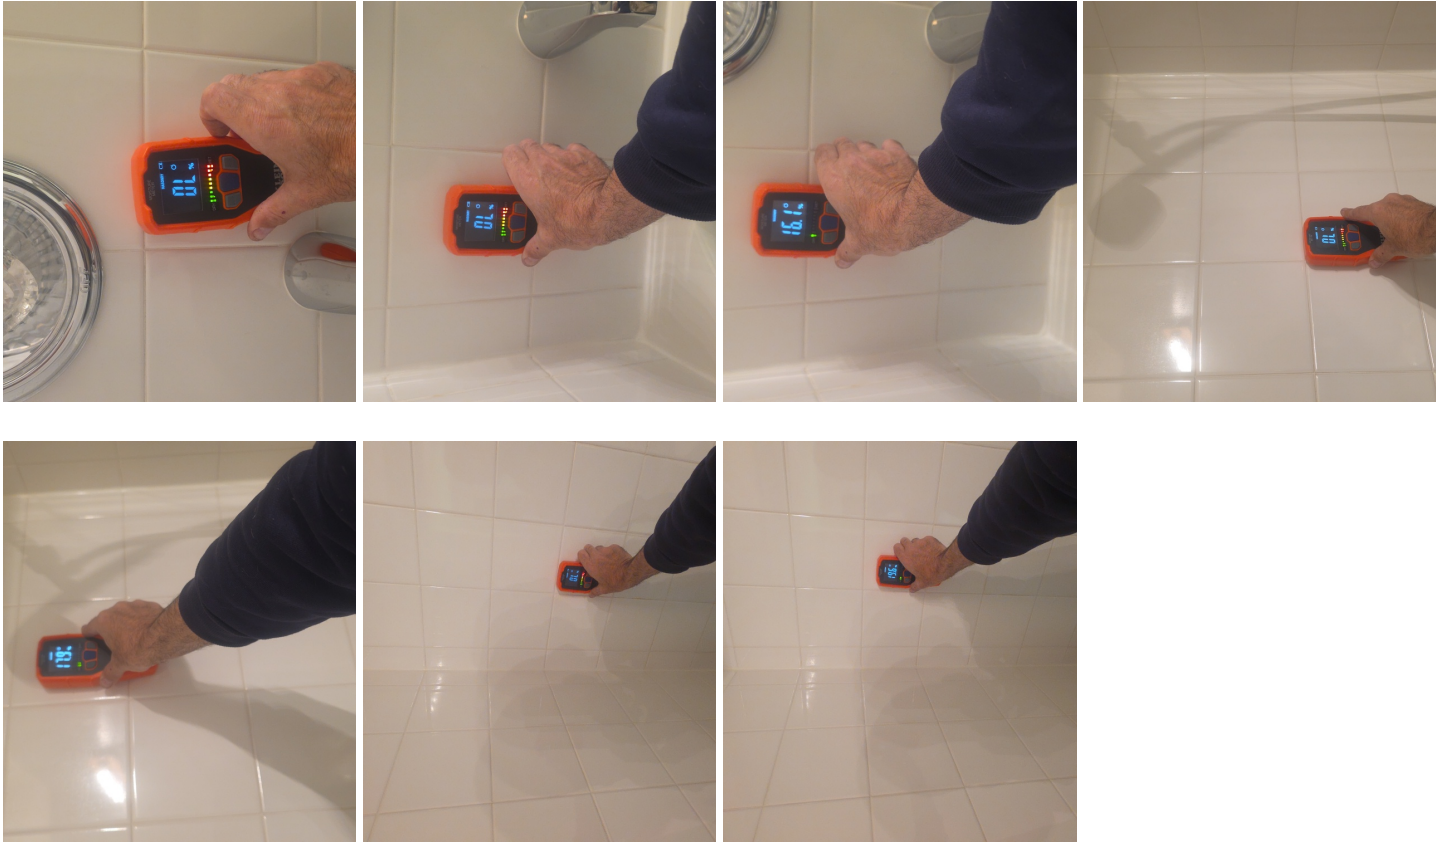
### Moisture Detected Behind Shower Walls

Moisture was detected behind the shower tile using a moisture meter, indicating moisture intrusion behind the finished surface. The extent of concealed damage could not be determined during this visual inspection. Recommend evaluation by a qualified contractor and repair as needed, which may include removal of tile and replacement of any damaged materials.

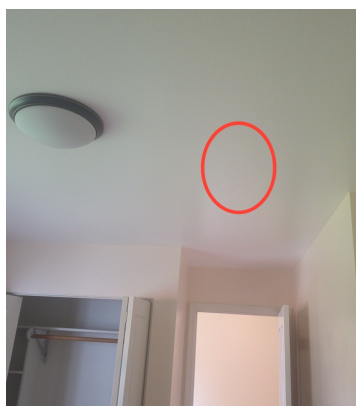
#### Smoke Detectors Missing

At least one smoke detector is missing. Have qualified contractor install smoke alarms to meet current requirements.

Note: MOA Policy R.18 requires interconnection of battery operated types.

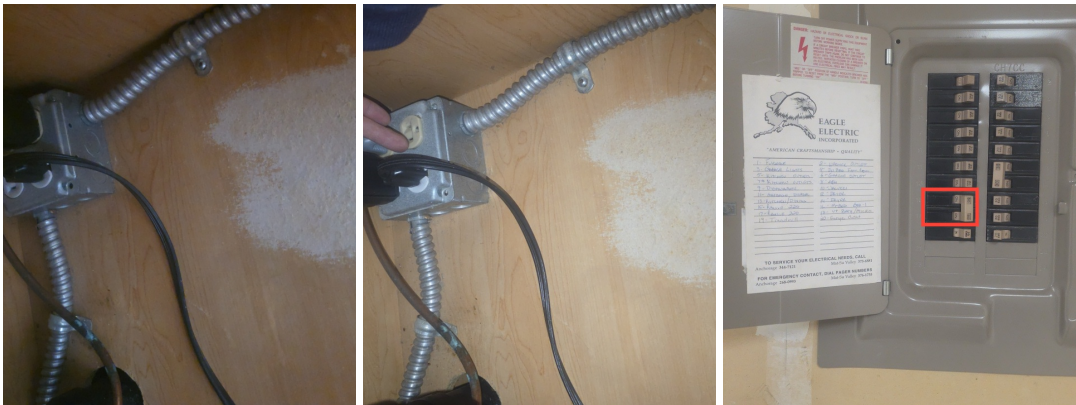
#### Gfci Protection Missing

Note 3-wire 240v cords and receptacles need to be replaced with 4-wire for proper separation of ground and neutral conductors.

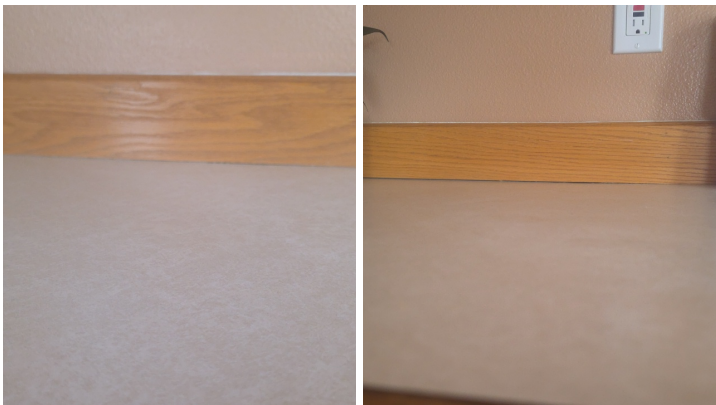
Caulking Worn/ Cracking

The caulking is worn and cracking. Have qualified professional remove and replace caulking at backsplash to prevent moisture intrusion.

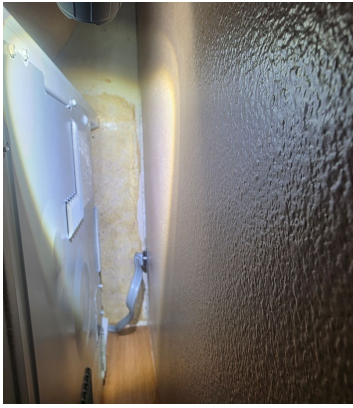
Anti-tip Missing

The anti-tip bracket is missing. Have qualified professional install anti-tip bracket for child safety.

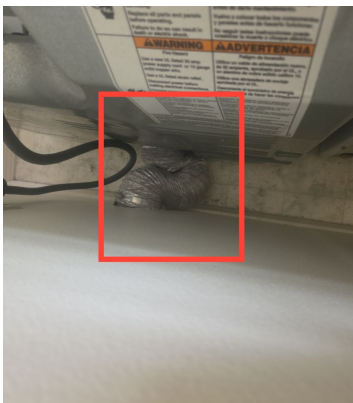
##### Dryer Vent Duct Restricted

The flexible dryer exhaust duct was excessively kinked/compressed behind the dryer, restricting airflow. Restricted dryer exhaust can reduce dryer performance, increase lint accumulation, and create a potential fire hazard. Recommend replacing the flexible duct with a properly installed rigid or semi-rigid metal transition duct and ensuring the exhaust path is free of excessive bends or kinks.

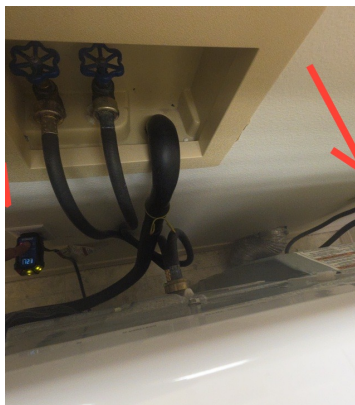
All 120v and 240v receptacles in laundry areas are required to be gfcı protected. Recommend having qualified professional install gfcı protection for all 120 and 240v receptacles in laundry area. (3 prong receptacles and cords will need replaced with 4 wire for separation of grounding/ neutral conductors as required.)

##### GFCI Protection Required

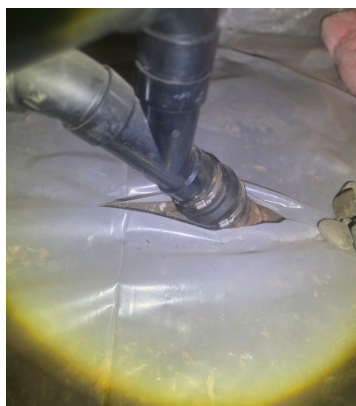
Moisture Present At Crawlspace Vapor Barrier

Standing water and staining were observed on top of the crawlspace vapor barrier. The source of the moisture could not be determined during the inspection. A qualified contractor should further evaluate the crawlspace to identify and correct the source of the moisture. After repairs are completed, any standing water should be removed, and the crawlspace should be monitored to verify the issue has been resolved. Continued moisture intrusion can contribute to wood decay, mold growth, and other moisture-related damage.

The vapor barrier is not sealed to the foundation wall and penetrations as required. Recommend adhering vapor barrier to foundation walls with acoustical sealant and tape any holes, seams and penetrations.

#### Moisture Present At Crawlspace Vapor Barrier

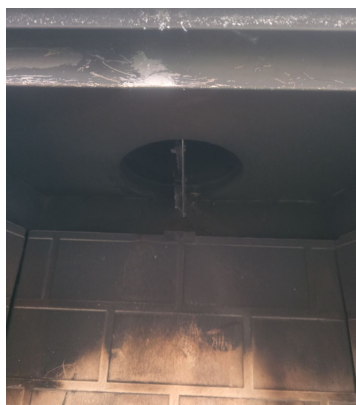
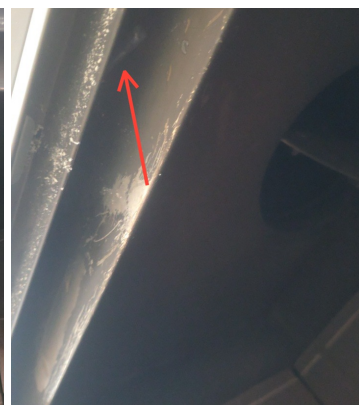
The fireplace damper was missing its operating handle and did not remain in the closed position during inspection. A properly functioning damper is necessary to control air-flow, improve energy efficiency, and help ensure safe fireplace operation. Recommend a Level 2 chimney inspection and repair or replacement of the damper assembly by a qualified chimney professional prior to using the fireplace.
